SERVICE TEST OF

RECOVERY VEHICLE, FULL-TRACKED:

LIGHT ARMORED (M113A1), XM806E1

FINAL REPORT

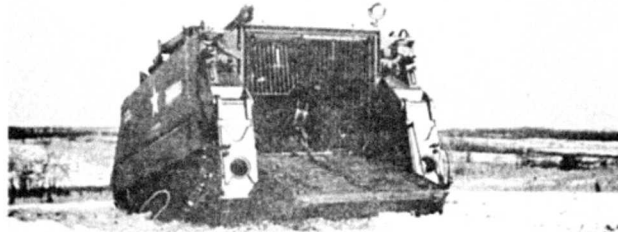
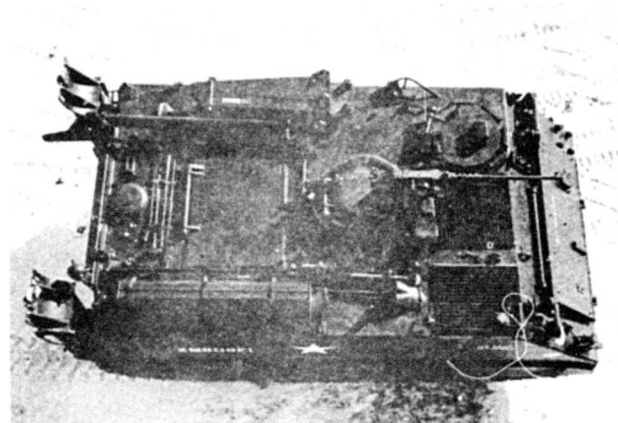
US ARMY ARMOR AND ENGINEER BOARD USATECOM PROJ NO 1-7-2625-34
FORT KNOX, KY PHOTO NO 2-147-16D AND 2-147-16I

UPPER: VEHICLE POSITIONED FOR
RECOVERY OPERATION

LOWER: ELEVATED VIEW OF XM806E1

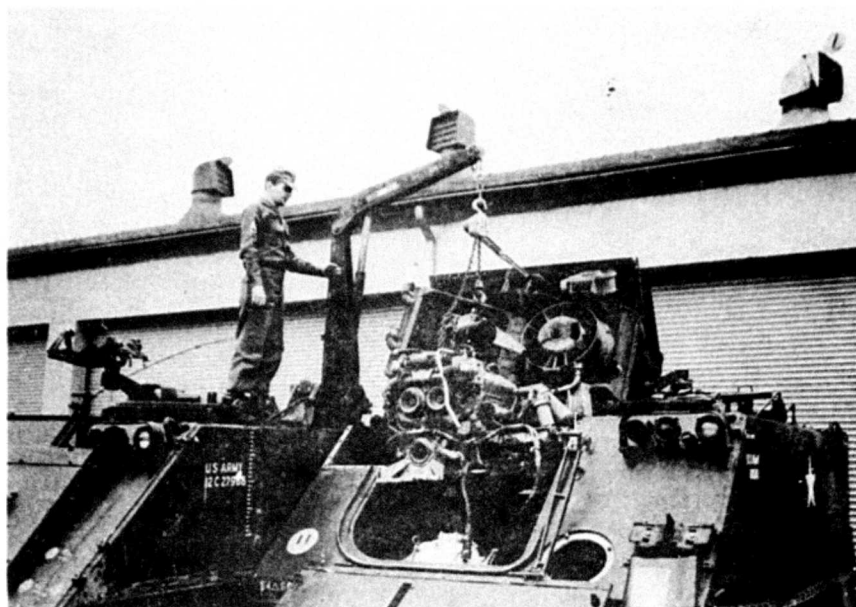
US ARMY ARMOR AND ENGINEER BOARD USATECOM PROJ NO 1-7-2625-34
FORT KNOX, KY PHOTO NO 69-125A

2.5.3.5 Utilizing a boom radius of 60 inches, the auxiliary crane satisfactorily removed and replaced the power pack of the comparison vehicle. (See photo, page I-3, app I.) With the crane holding the pack, transportation from one shop area to another was accomplished. The crane also lifted and held (during transport) filled 55-gallon drums.

REMOVAL OF POWER PACKAGE FROM
STANDARD M113A1 ARMORED PERSONNEL CARRIER
